Pythian Powerhouse and Laundry

Historic Building Survey

August 2008

(Building No. 503)

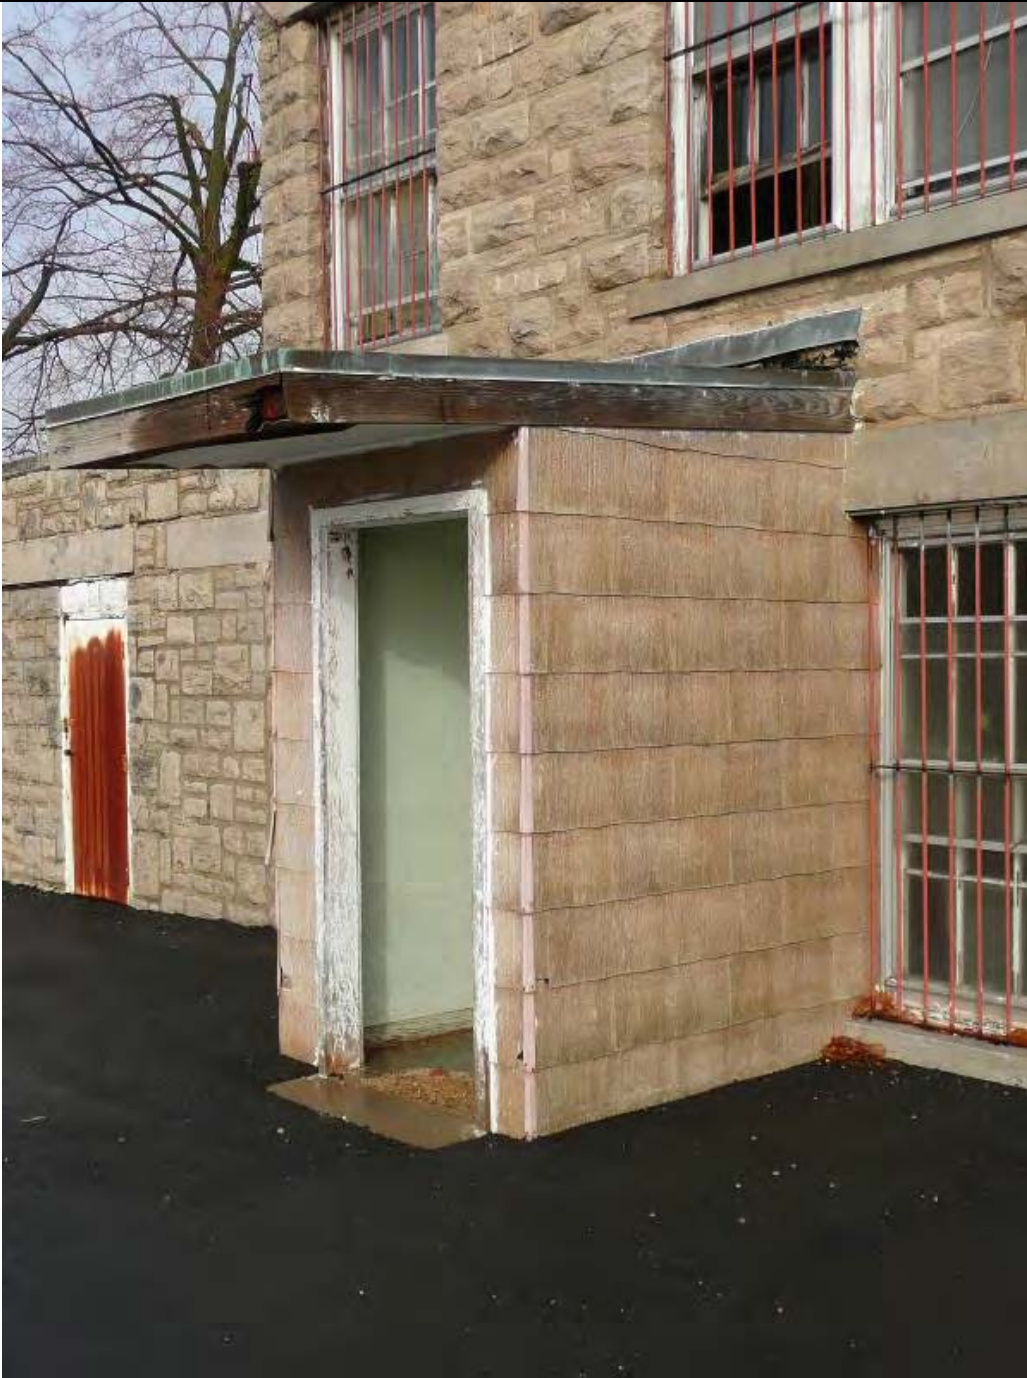
Photo 5 – close-up of vestibule addition on south elevation

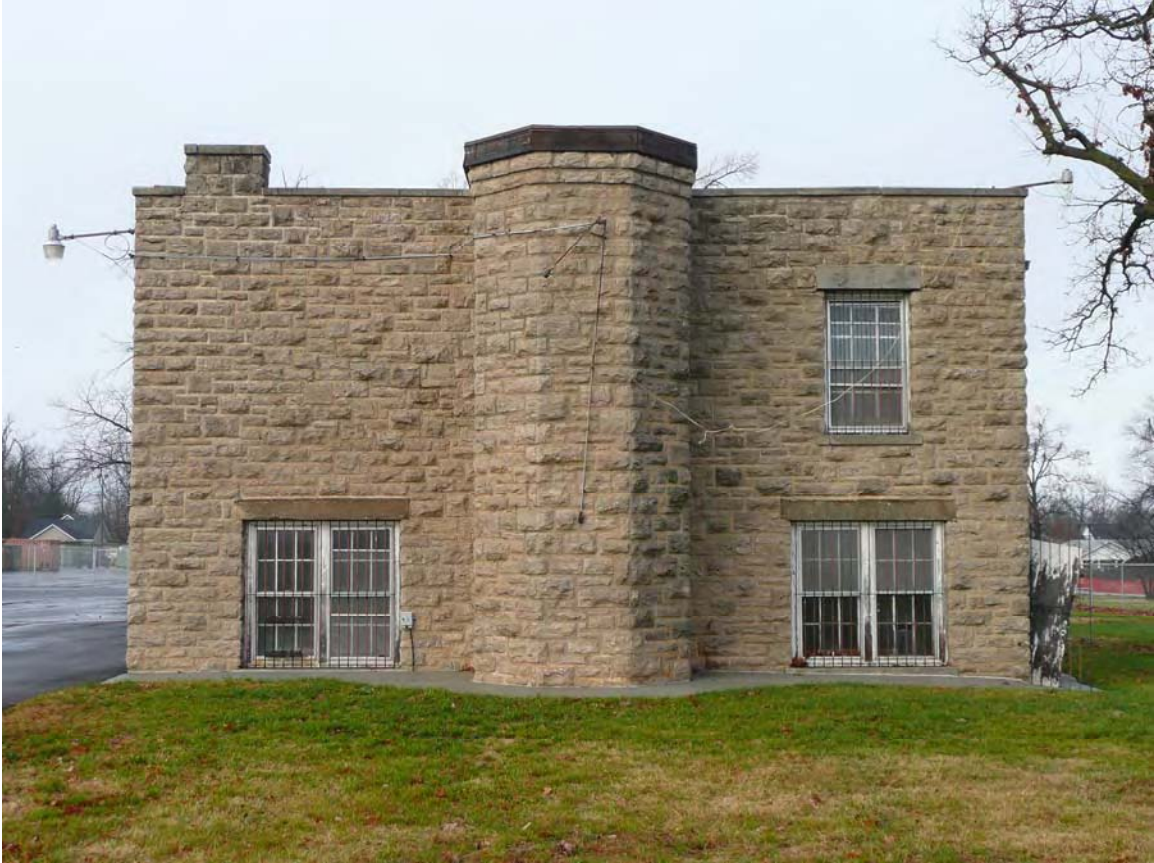
The east elevation (Photo 9) is where the original chimney stack was located. A majority of the stack is intact; however, the top portion of the stack that extended above the two-story roof height has been removed and has been capped off (Photo 10). The chimney is located in the center of the elevation and is five-sided. There are two sets of paired wood double-hung windows on the first floor; one on each side of the chimney. One single six-over-six wood double-hung window is to the right of the chim-

Photo 9 – east elevation; overall view

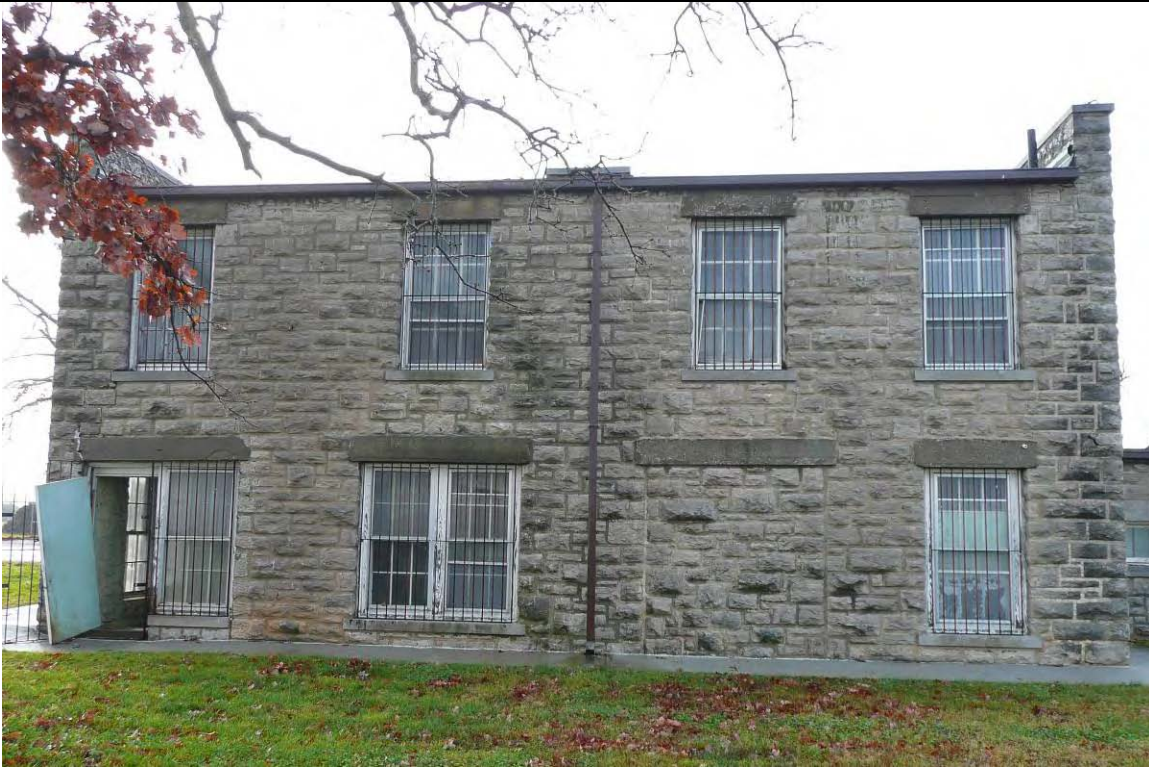
The north elevation (Photo 11) is defined by several window openings. The majority of the elevation is two-stories tall. The first floor of the two-story exterior wall has a window opening modified with one window and a replacement door (Photo 12), one set of paired six-over-six wood double-hung windows, a modified window opening that has been filled in with stone, and one single six-over-six wood double-hung window. The second floor consists of four evenly spaced single six-over-six wood double-hung windows. All of the windows have concrete windowsills and lintels and are covered with metal security bars. The right side of the north elevation is recessed from the two-story portion. The right side is one-story tall and has one smaller three-pane wood awning window with a concrete windowsill and a small single-pane fixed window without a concrete windowsill (Photo 27).

Photo 11 – left side of the north elevation; overall view

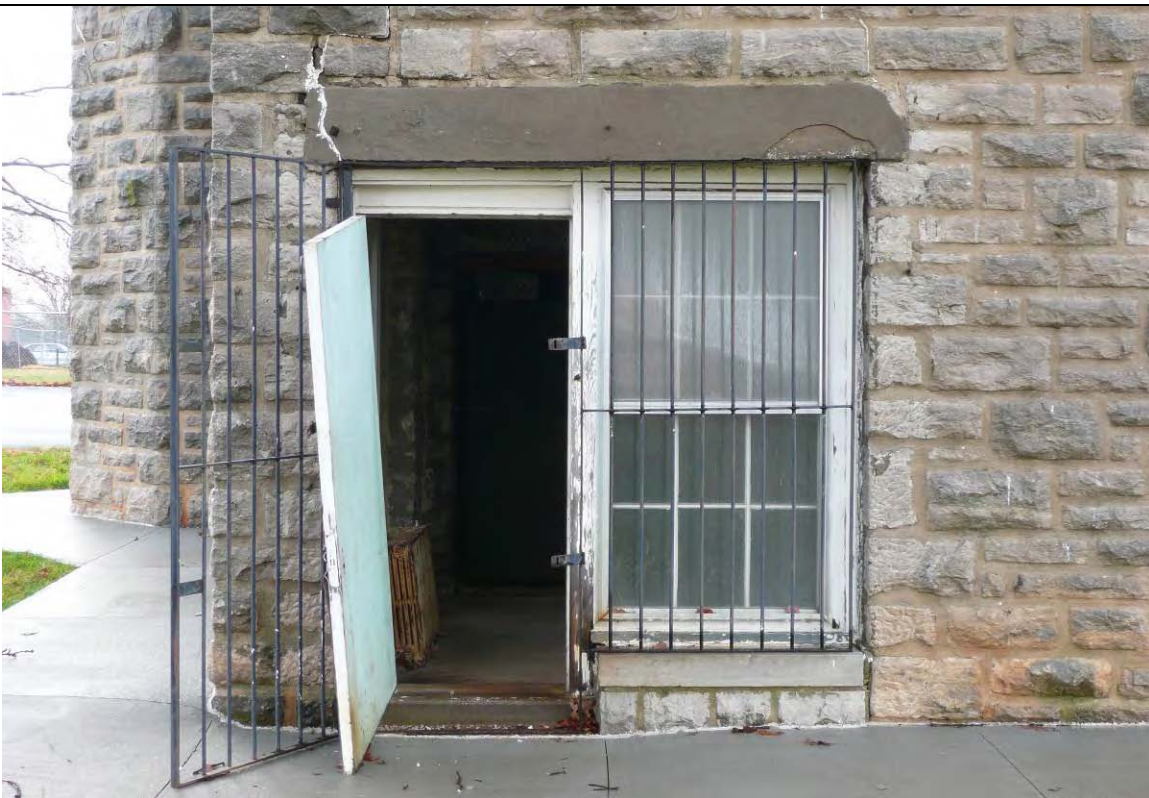
Photo 12 – close-up of window modification on north elevation

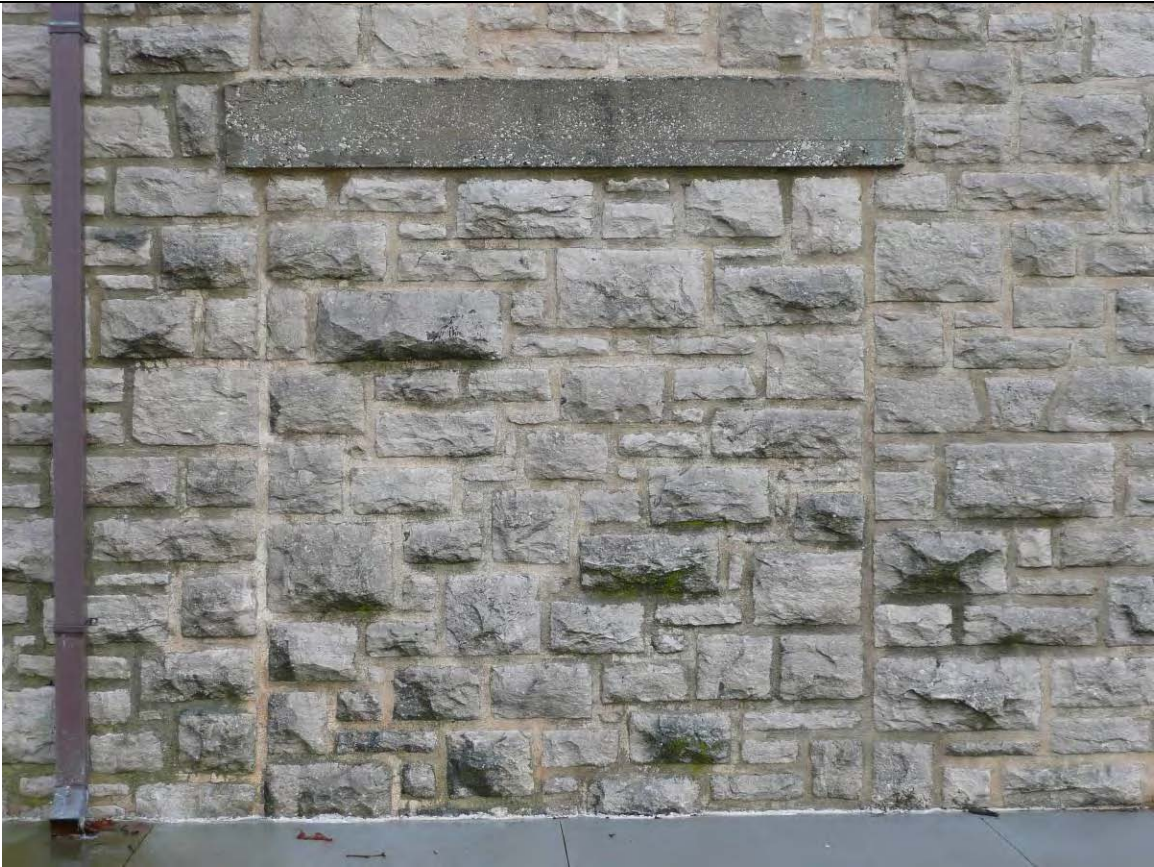
Photo 26 – Type 8 window
